# Wildcat Shale Pit Remediation Project, Petite Rivière Watershed, Lunenburg County, NS

RRFB Research & Development  
Project No. RD-R6-15-03

BLUENOSE COASTAL ACTION FOUNDATION

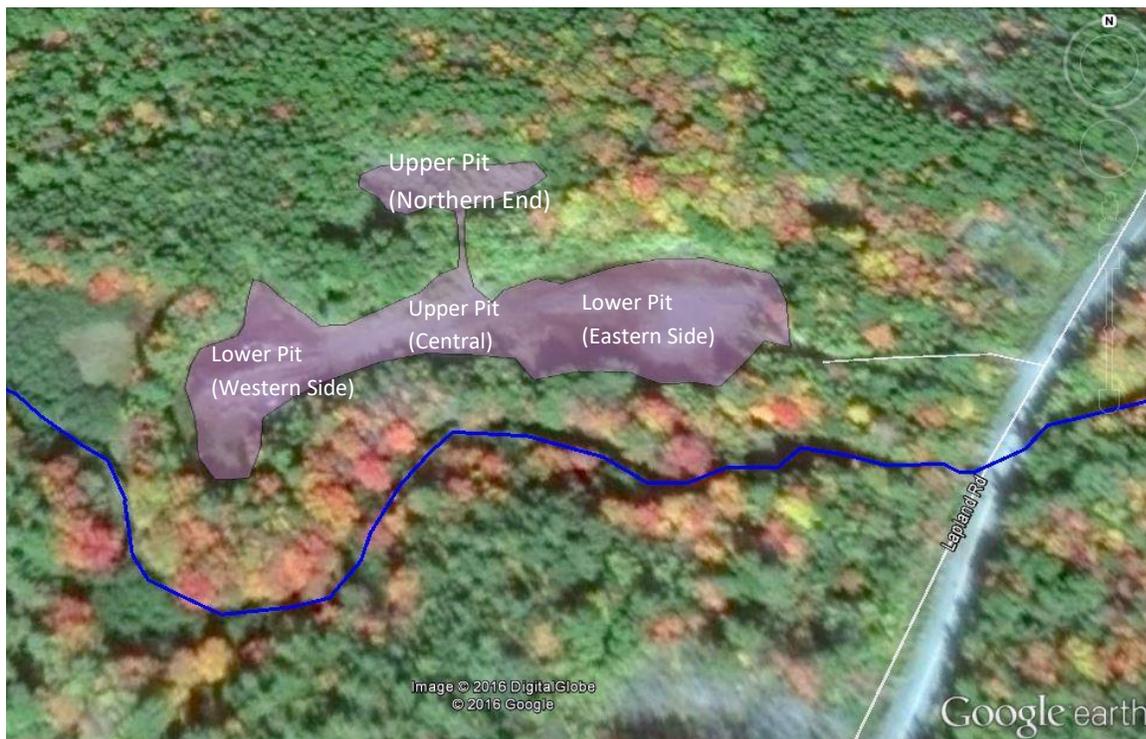
The proposed shale pit remediation site consists of bare rock with very minimal amount of soil and sparse shrub vegetation. The site is surrounded by a mix-wood forest stand. Western and Eastern sides of the remediation site (Figure 1) are lacking of any larger vegetation and have collected rainwater in small, low lying pools. The pools all had low acidity readings (average pH of 4.2) and lack aquatic vegetation growth within them. The Central and Northern end of the site is at a higher elevation and larger vegetation is present. This larger vegetation has likely only been established for approximately 10 to 15 years. White Pine (*Pinus strobus*) and Gray Birch (*Betula populifolia*) are the dominant species and appear sickly and yellow in colour. This is likely caused by the lack of nutrients in the soil found in these areas.

Figure 1. Aerial view of Wildcat Shale Pit Remediation site shaded grey with adjacent Wildcat Brook depicted with blue line.

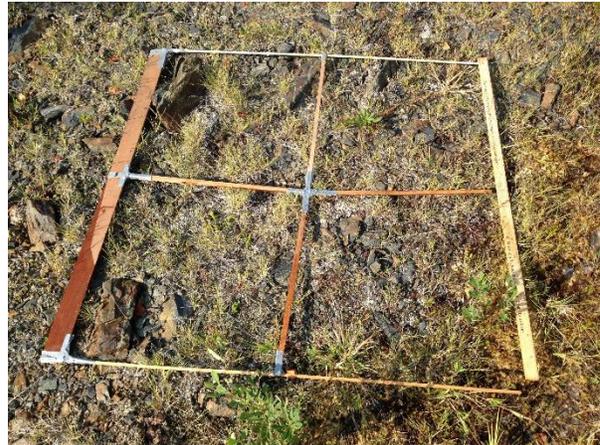
Figure 3. Vegetation density measurements taken with 1x1 square grid.

during pre-restoration conditions. The vegetation surveys included recording a list of all vegetation found to determine the diversity of plant life. These surveys were conducted under the guidance of Nova Scotia plant expert, Dr. Ruth Newell. Density measurements were determined using a randomized 1 m<sup>2</sup> transect in four different sections of the shale pit.

**Method:** Remediation site was split into four sections (1-lower right, 2-upper right, 3-upper left, and 4-lower left) with each section sampled five times using a 1x1 square grid to measure randomized locations for percent of vegetation. *These measurements do not account for large vegetation such as trees.*

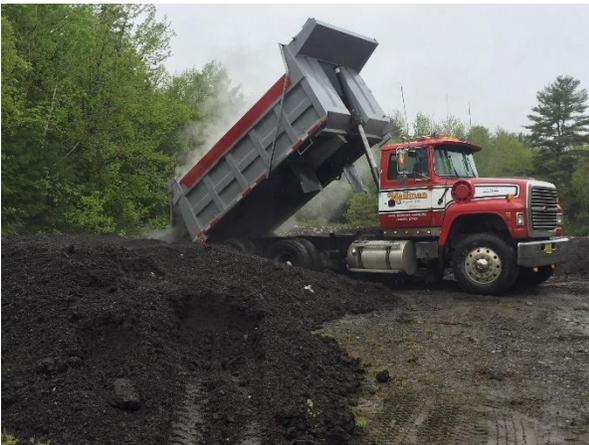
Figure 4. Dumping load of municipal compost.

Approximately 400 m<sup>3</sup> of municipal compost material was used in the higher elevated areas (Upper Pit) of the restoration site. The nutrient-rich organic soil will encourage and support a healthy growth of vegetation in the high-lying areas of the restoration site, while the low lying areas are nutrient depleted. The high-lying areas will support larger types of vegetation such as large trees and shrubs rather than the wetland grasses, sedges, reeds, and flowers proposed for the lower lying areas. The areas covered with compost material have been seeded with a native reclamation grass mixture and already have young tree development.

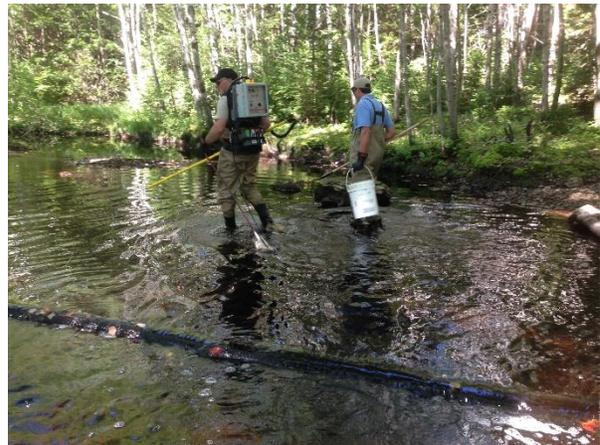
Figure 5. Conducting electrofishing survey in Wildcat Brook.

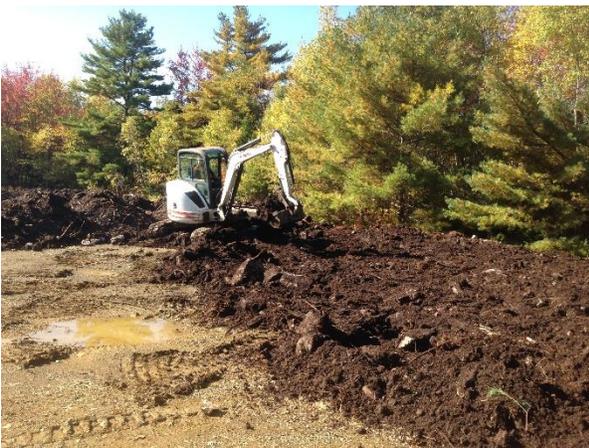
Figure 6. Spreading and landscaping with excavator in Western side of Wildcat Shale Pit Remediation Site.

The 1.10-hectare shale pit was capped by adding and spreading approximately 2600 m<sup>3</sup> of organic soil and vegetation to cover the exposed pyritic slate preventing it from oxidizing. The bulk spreading of organics occurred using East Coast Aquatics' excavator and frontend loader tractor. These soils were sourced from development projects in the area that were excavating and removing wetland/organic soils. The low-lying areas (Lower Pit) of the remediation site are flooded and vegetated with native wetland vegetation to encourage the formation of wetland habitat.

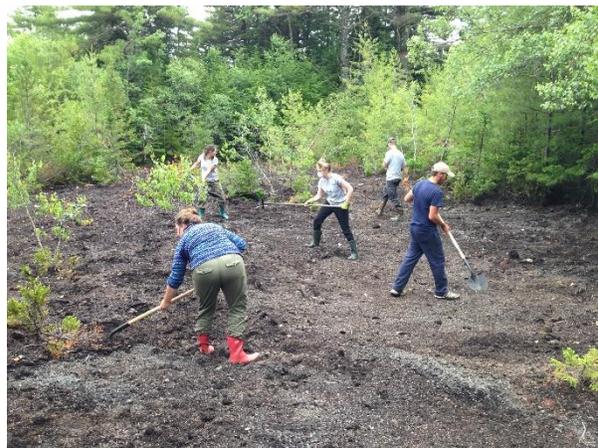
Figure 7. Hand spreading of compost in Northern end of Wildcat Shale Pit Remediation site.

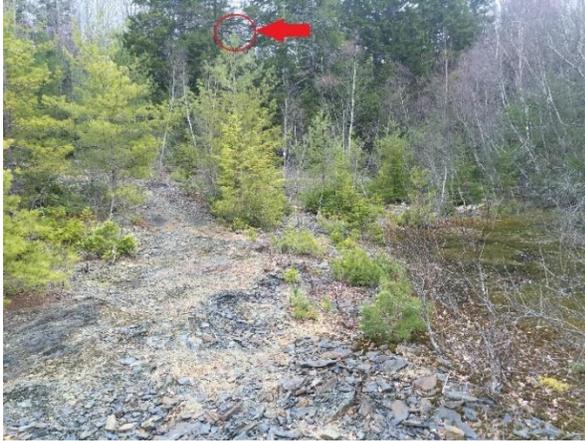
Due to the nature of this project the results are in a preliminary stage. Vegetation in the Central and Northern end of the Shale Pit Remediation site will continue to grow up and fill in. These changes will be documented through point photos and observing vegetation growth. Photos below illustrate the Northern end of the remediation site prior to the spreading of compost and after the spreading of compost over exposed pyritic slates.

*Figure 8. Northern end of Shale Pit Remediation site on May 3, 2016.*

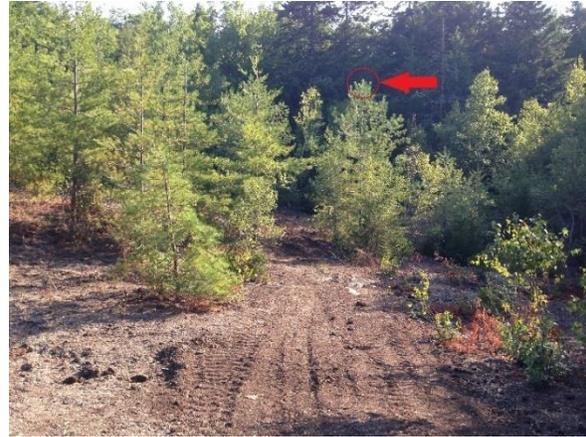
*Figure 9. Northern end of Shale Pit Remediation site on August 12, 2016 after compost material had been spread.*
